e x t r a ! O R I O N

Newsletter of the
Friends of Astronomy
Cornell University
Special Hubble Repair issue 2009

The Hubble SM4 Repair Mission

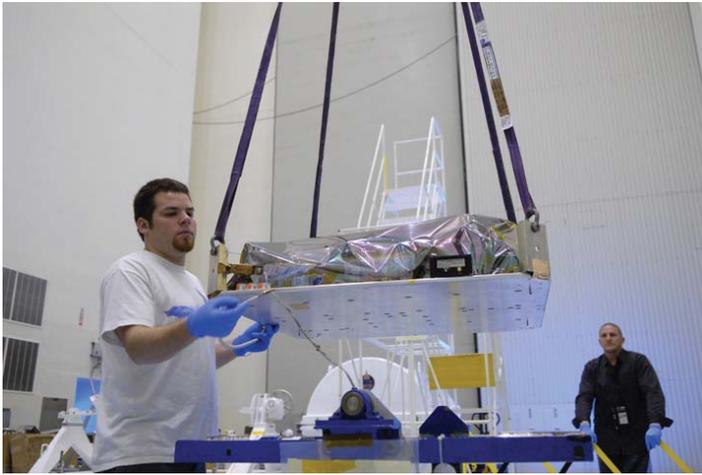
In the Payload Hazardous Servicing Facility at NASA's Kennedy Space Center in Florida, technicians attach straps from a crane in order to lift the Science Instrument Control and Data Handling Unit, or SIC&DH, which was installed by astronauts John Grunsfeld and Drew Feustel on the first day of repairs. Credit: *NASA/Jack Pfaller*.

The astronauts also replaced the Science Instrument Control and Data Handling Unit (SIC&DH), another very high-priority piece of equipment necessary to format data and transfer commands between the science instruments and the hardware that transmits data to the ground. One of these two units failed unexpectedly last October, leading to a 7-month delay in the present servicing mission. By replacing this unit, the astronauts have ensured that there is once

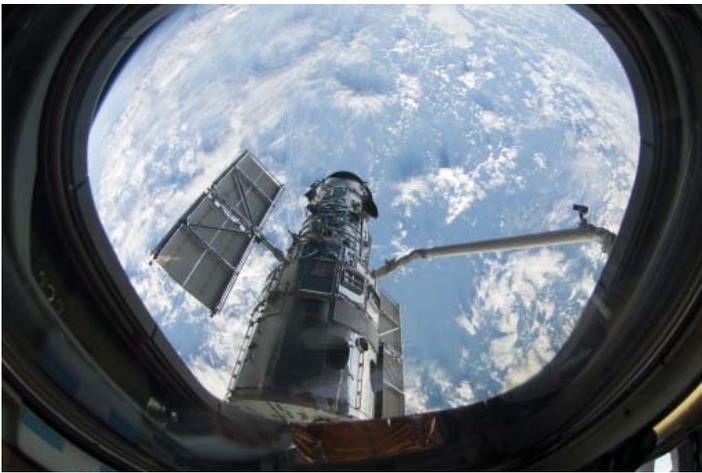
13 May 2009, third day of flight. An STS-125 crewmember onboard the Space Shuttle Atlantis snapped a still photo of the Hubble Space Telescope following grapple of the giant observatory by the shuttle's Canadian-built remote manipulator system on the third day of flight. Credit: *NASA/Hubble Heritage Team (STScI/NASA)*.

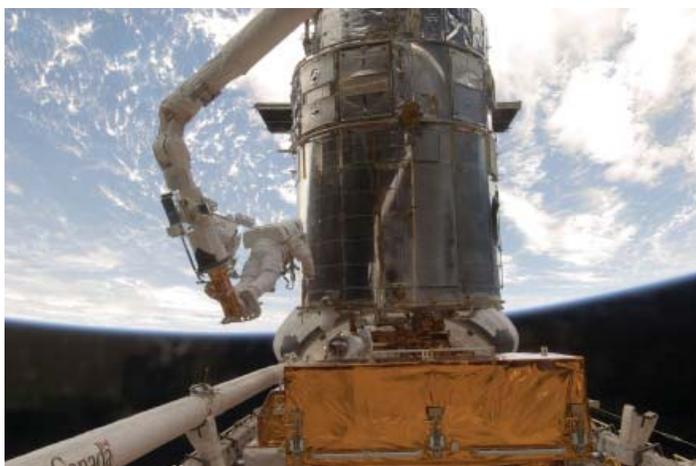
16 May 2009, sixth day of flight and third of repairs. Astronauts Andrew Feustel and John Grunsfeld (partially obscured at bottom) working on refurbishing and upgrading the Hubble Space Telescope. During the six-hour, 36-minute spacewalk, Grunsfeld and Feustel removed the Corrective Optics Space Telescope Axial Replacement and installed in its place the new Cosmic Origins Spectrograph. They also completed the Advanced Camera for Surveys electronic card replacement work, and completed the second part of the ACS repair, installing a new electronics box and cable. Credit: NASA/Hubble Heritage Team (STScI/NASA).

John Grunsfeld and Drew Feustel were again the spacewalkers on this day. The Cosmic Origins Spectrograph installation proceeded smoothly. The old COSTAR device (originally installed to correct the 'myopia' in HST's primary mirror, but no longer needed by the newer instruments) was demated and removed from its bay, COS was installed and mated, and COSTAR was stowed for return to Earth in the same protective enclosure in which COS was carried to orbit. It sounds simple, but was only possible because of all the training and preparations by hundreds of people on Earth ahead of time! COS is designed to study the very faint ultraviolet signatures of the most distant objects in the universe, notably quasars, and to use them to probe the extremely tenuous intergalactic medium.

The repair of the Advanced Camera for Surveys is the first time a Hubble instrument has been opened on-orbit to replace electronics boards. In the case of ACS, this required several complex tasks. To gain access to the four boards needing replacement, John had to cut an aluminum grid, about as thick as a CD, with a special grid cutter. Then it was necessary to remove the electronics board enclosure cover, which has 32 small screws. A fastener capture plate was installed over the enclosure cover to keep the screws from drifting away. Once the cover was removed and after loosening and extracting four electronics boards, John inserted a replacement unit containing a set of four new boards and an integral replacement cover. The four replacement boards were seated one by one. The task was completed by attaching a new low voltage power supply to the outside of the instrument and routing power and communications cables between the new units and the existing connectors. The repair was completed well ahead of schedule.

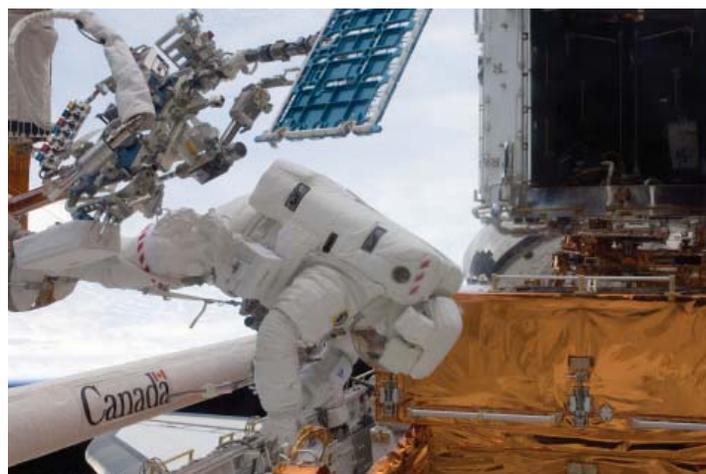
17 May 2009, seventh day of flight and fourth of repairs. Astronaut Michael Good working on the Space Telescope Imaging Spectrograph. Credit: NASA/Hubble Heritage Team (STScI/NASA).

Day 4 was Mike Massimino's and Mike Good's turn to tackle the STIS repair, considered by many to be the trickiest item on the list. In the early phases of the repair activities, Mike Massimino had to remove a large handhold on STIS that is in the way of the removal of a cover plate. In the process of removing the four bolts that hold that handle, one of the bolt heads was stripped and resisted all further attempts to remove it, in spite of several trips to various storage boxes in the payload bay to retrieve special tools. Finally, the call went up to Atlantis to simply break off the handle, which Mike did in short order. After this little problem, all seemed to be set for removing the cover plate with its infamous 111 screws, just to find out that the Mini-Power Tool ("screwdriver") had an empty battery. More time had to be spent to retrieve the spare from the air lock. After that, things went fairly smoothly. The screws were removed and captured in the so-called Fastener Capture Plate. The old faulty low-voltage power supply electronics board

was removed, and the replacement put in. Finally a new cover was put on.

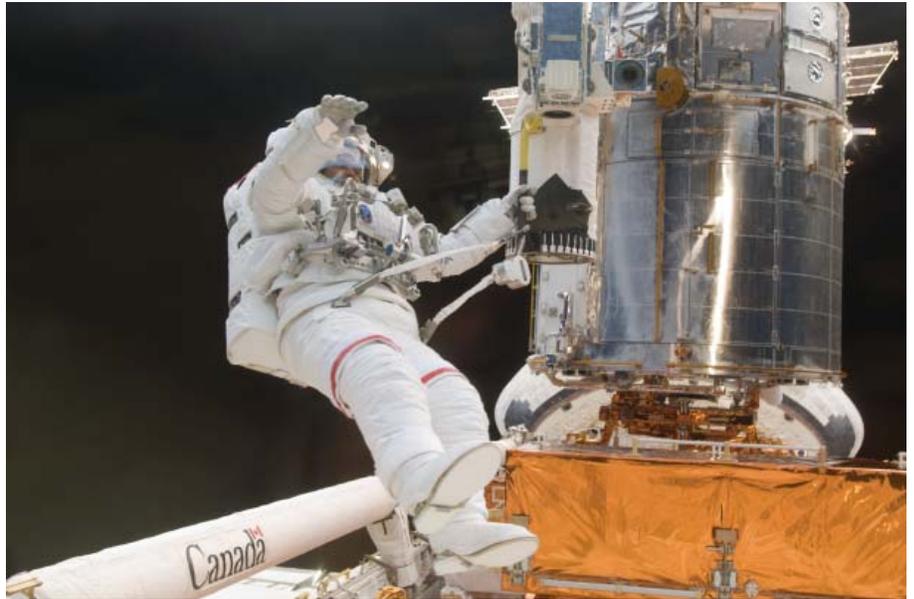
18 May 2009, eight day of flight and fifth day of repairs. Astronauts John Grunsfeld and Andrew Feustel (out of frame) installed a battery group replacement, removed and replaced a Fine Guidance Sensor and three thermal blankets (NOBL) protecting Hubble's electronics. Credit: NASA/Hubble Heritage Team (STScI/NASA).

The final EVA saw John Grunsfeld and Drew Feustel in action again. First, they installed a second set of replacement batteries without any problems. Next came the replacement of one of the Fine Guidance Sensors. A few minor problems occurred while opening the doors, and the so-called A-latch resisted again, similar to what happened during the removal of WFPC2 during EVA-1. After a few tries with increasing torque settings on the power tool, it was again down to a wrench (without torque limiter), John's touch, and a little elbow grease. That did it again, and the A-latch yielded. The rest of the FGS replacement went very smoothly. The twin FGS units are

essential for HST to point precisely at celestial targets, and are also scientific instruments in their own right. No FGS has ever failed, but each has been returned to Earth and refurbished at least once.

The installation of the insulating New Outer Blanket Layers (NOBLs) over Bays 5 and 8 were the final scheduled tasks of the mission, and were completed with time to spare. So it was decided to do the NOBL installation over Bay 7 as well, which had been lower priority task.

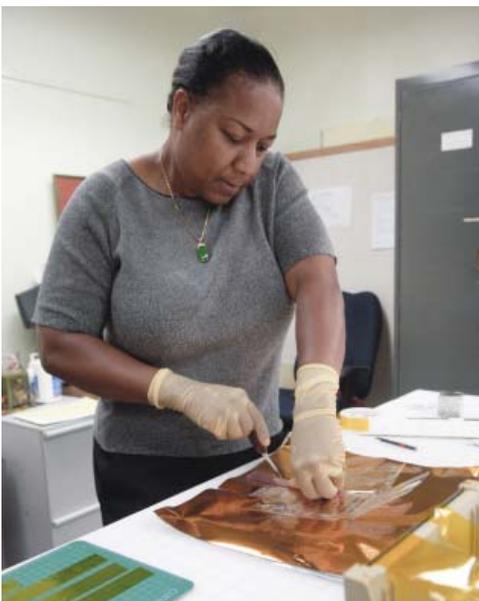
A technician cuts a piece of aluminum kapton film that became part of a thermal blanket. Credit: NASA.
